SATURN V LAUNCH VEHICLE FLIGHT EVALUATION REPORT-SA-513 SKYLAB 1

**SATURN V LAUNCH VEHICLE
FLIGHT EVALUATION
REPORT-SA-513
SKYLAB-1**

ABSTRACT

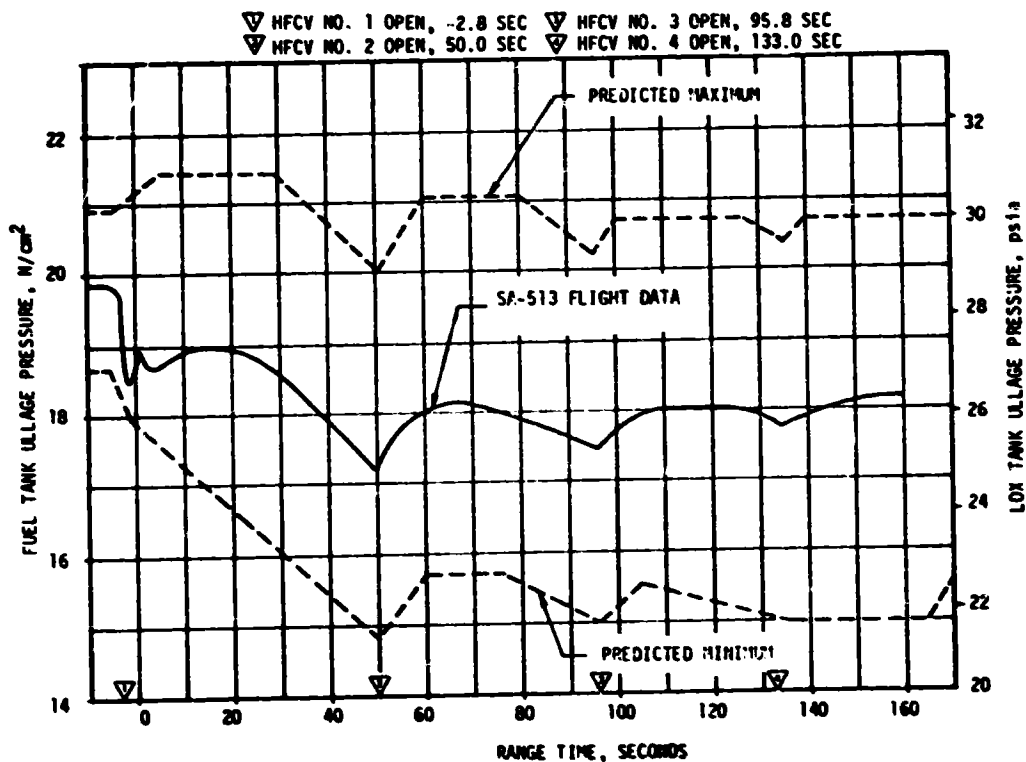
Figure 5-5. S-IC Fuel Tank Ullage Pressure

Fuel tank ullage pressure was within the predicted limits throughout flight as shown by Figure 5-5. HFCV No.'s 2, 3, and 4 were commanded open during flight by the switch selector within acceptable limits. Helium bottle pressure was 3031 psia at -2.8 seconds and decayed to 550 psia at OECO. Total helium flowrate was as expected.

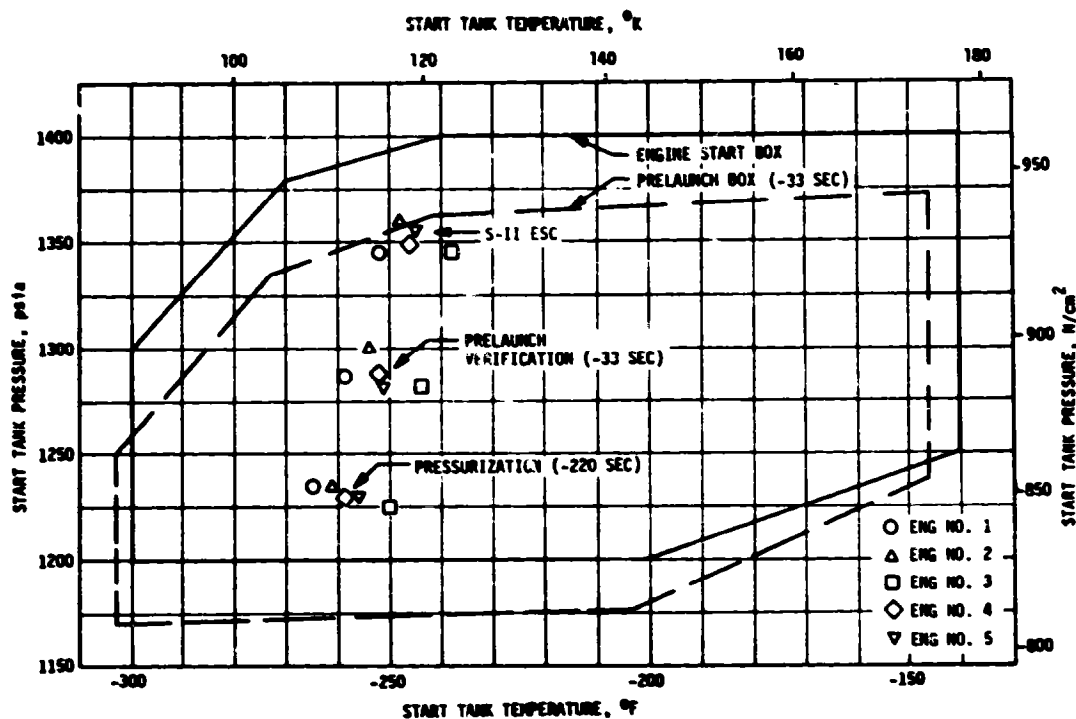
Figure 6-1. S-II Engine Start Tank Performance

Start tank system performance was satisfactory. Both temperature and pressure conditions of the engine start tanks were within the required prelaunch and engine start boxes as shown in Figure 6-1. Start tank temperature and pressure increase rates were normal during prelaunch and S-IC boost and no indication of start tank relief valve operation was noted.

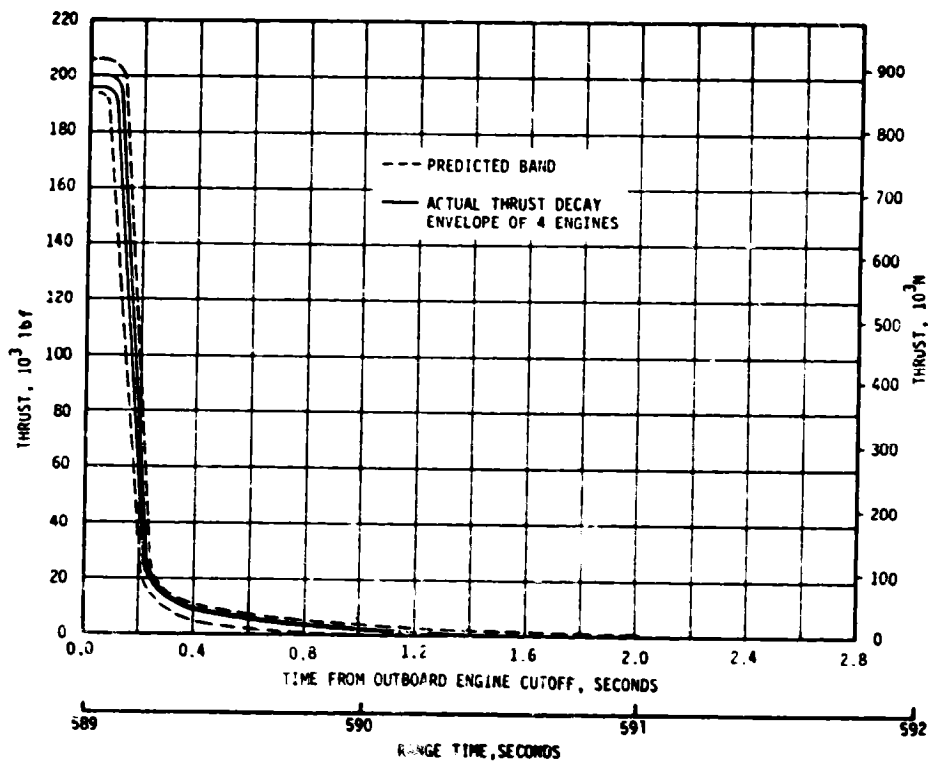
Figure 6-5. S-II Outboard Engines Thrust Decay

The outboard engine thrust decay performance was within the predicted band as shown in Figure 6-5. As expected, outboard engine performance did not exhibit decay prior to cutoff as on previous flights. This is attributed to the higher propellant head and lower temperature propellant at the engine inlets due to the higher propellant reserves left in the tanks with the velocity signaled cutoff versus the previous mode of operating to oxidizer depletion.

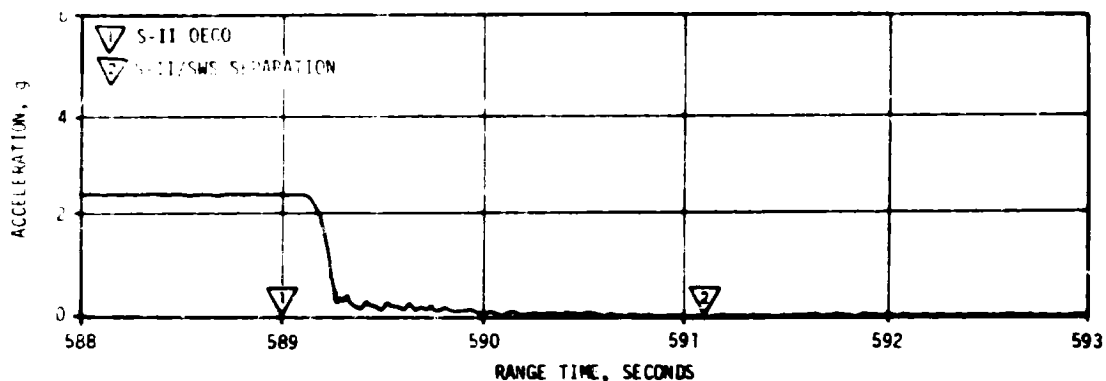
Figure 7-3. SA-513 Longitudinal Acceleration at IU During S-II Thrust Decay and S-II/SWS Separation

Maximum IU longitudinal dynamics at S-II cutoff and S-II/SWS separation are shown in Figure 7-3. The dynamics of ± 0.1 g are significantly lower than the preflight prediction of ± 0.5 g.

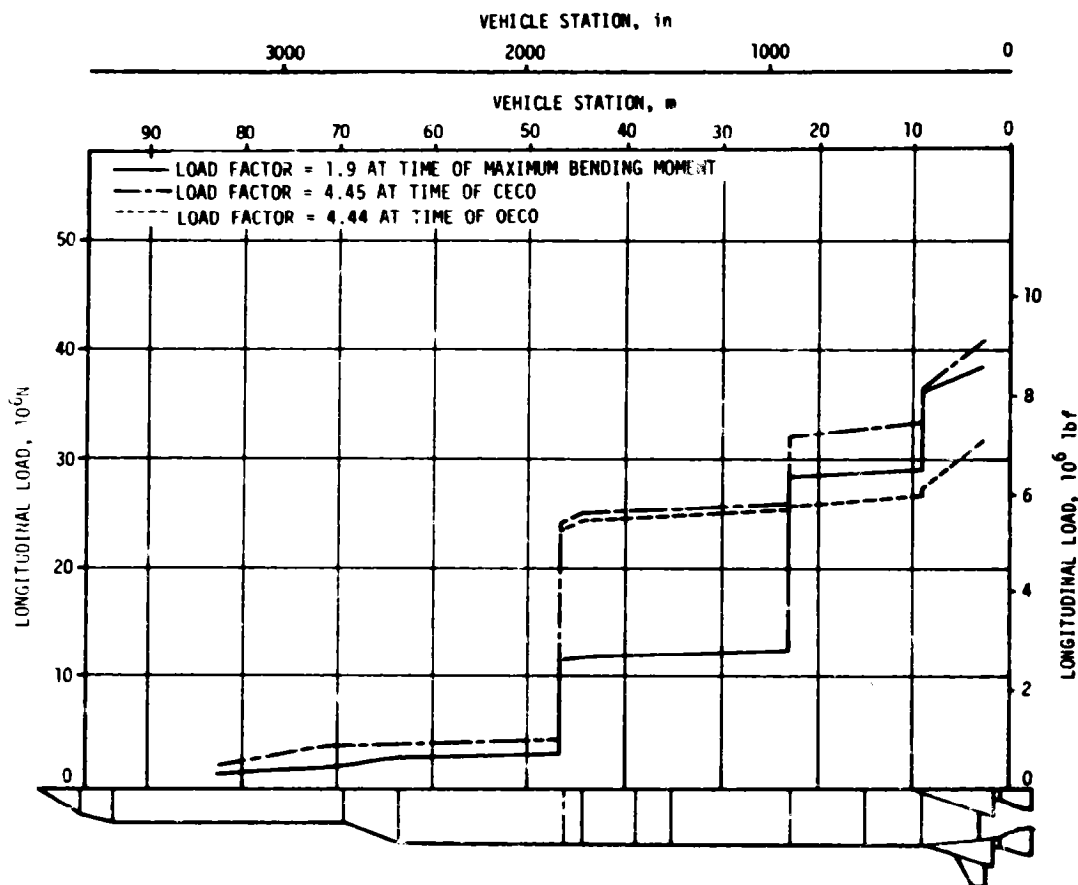
Figure 7-4. SA-513 Longitudinal Load Distribution at Time of Maximum Bending Moment, CECO and OECO

Combined compression and tension loads were computed for the maximum bending moment, CECO, and OECO conditions using the loads shown in Figures 7-4 and 7-5 and measured ullage pressures.

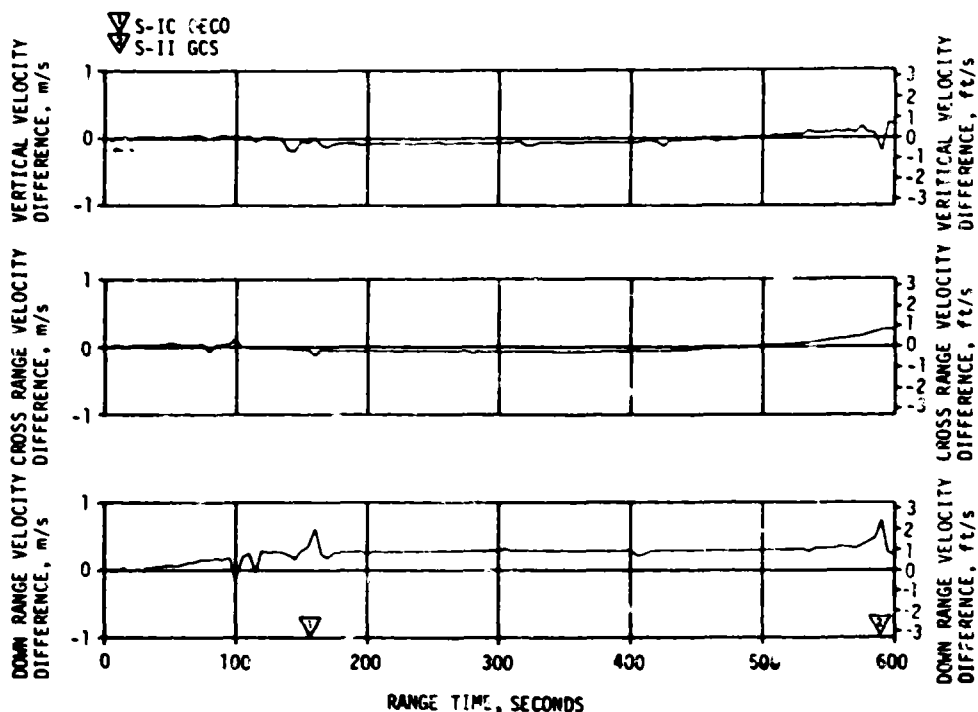
Figure 8-1. SA-513 Trajectory and ST-124M Platform Velocity Comparisons, Boost- to-Orbit Insertion (Trajectory Minus LVDC)

The postflight guidance error analysis was based on the comparisons of position and velocity data generated by guidance system with corresponding values from the final postflight trajectory (21-Day Observed Mass Point Trajectory, OMPT) which was established by consideration of both tracking and guidance system data (see Section 4). Comparisons of the inertial platform measured velocities (Project Apollo Coordinate System Standard (PACSS) 12) with corresponding OMPT data from launch to Orbit Insertion (OI) are shown in Figure 8-1. The differences in vertical and cross range velocities are very small throughout the flight. The downrange differences may indicate, in addition to small platform hardware errors,

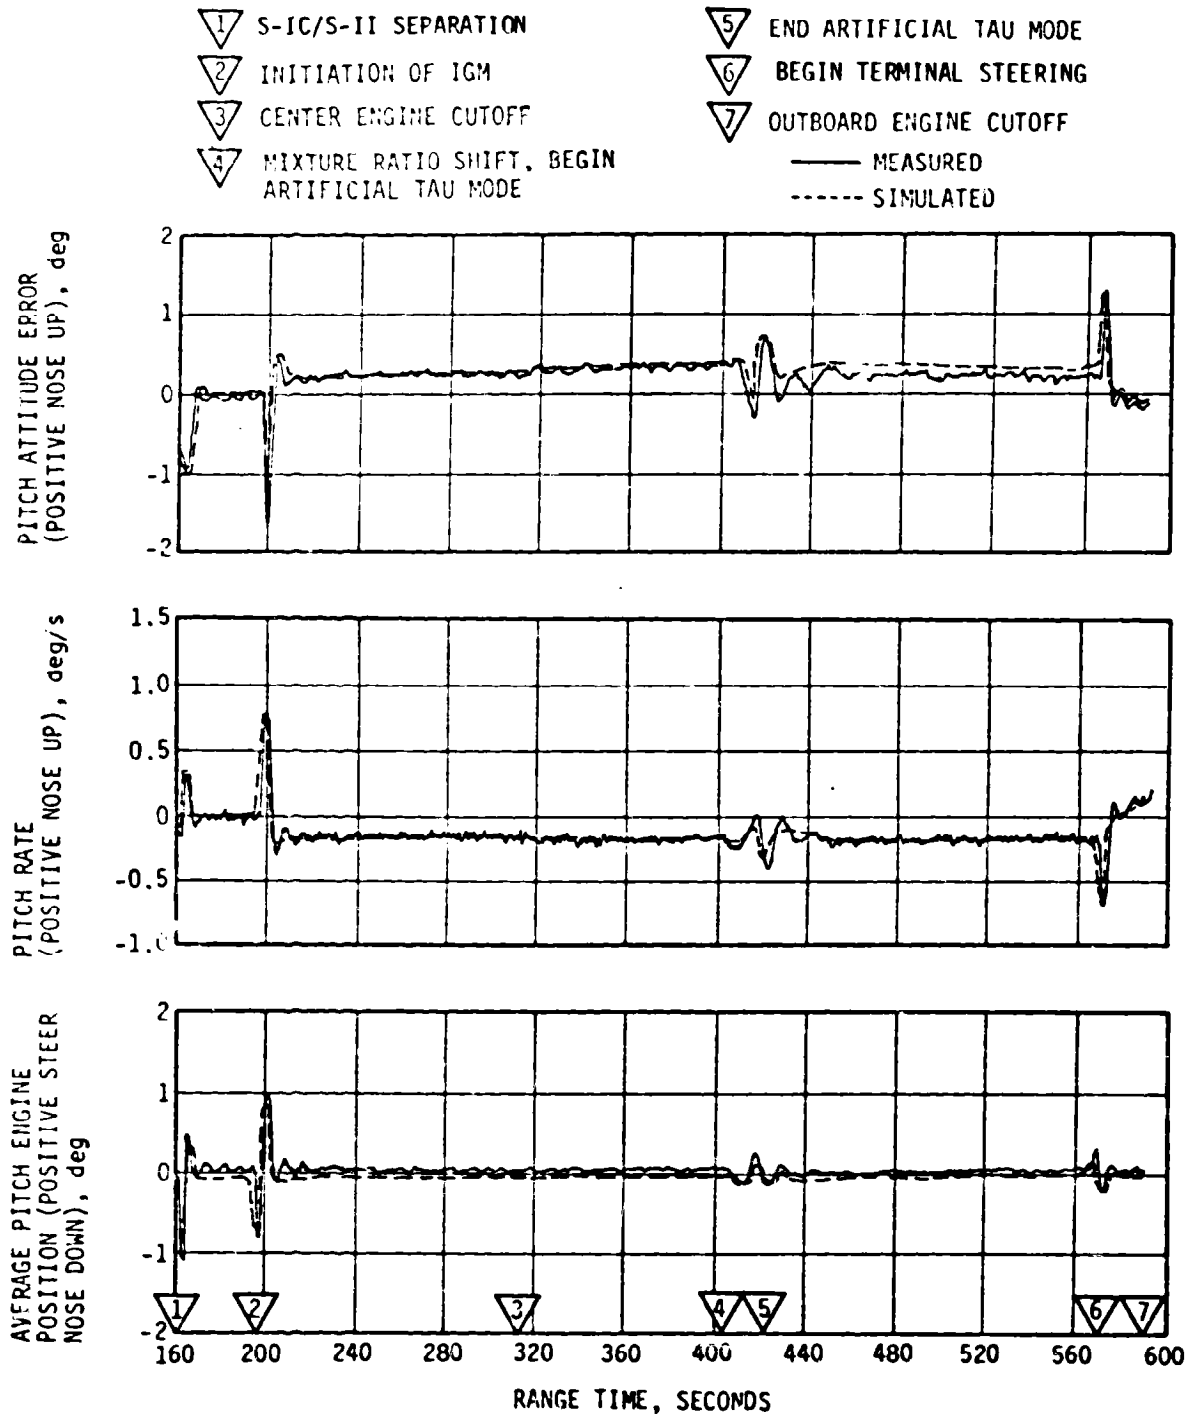
Figure 9-11. Pitch Plane Dynamics During S-II Burn

Flight and simulated data comparisons, Figures 9-11 and 9-12, show agreement at those events of greatest control system activity. Differences between the two can be accounted for largely by engine location misalignments, thrust vector misalignments and uncertainties in engine thrust buildup characteristics. The inflight thrust misalignments were found to be -0.1 degree about pitch and yaw axes.

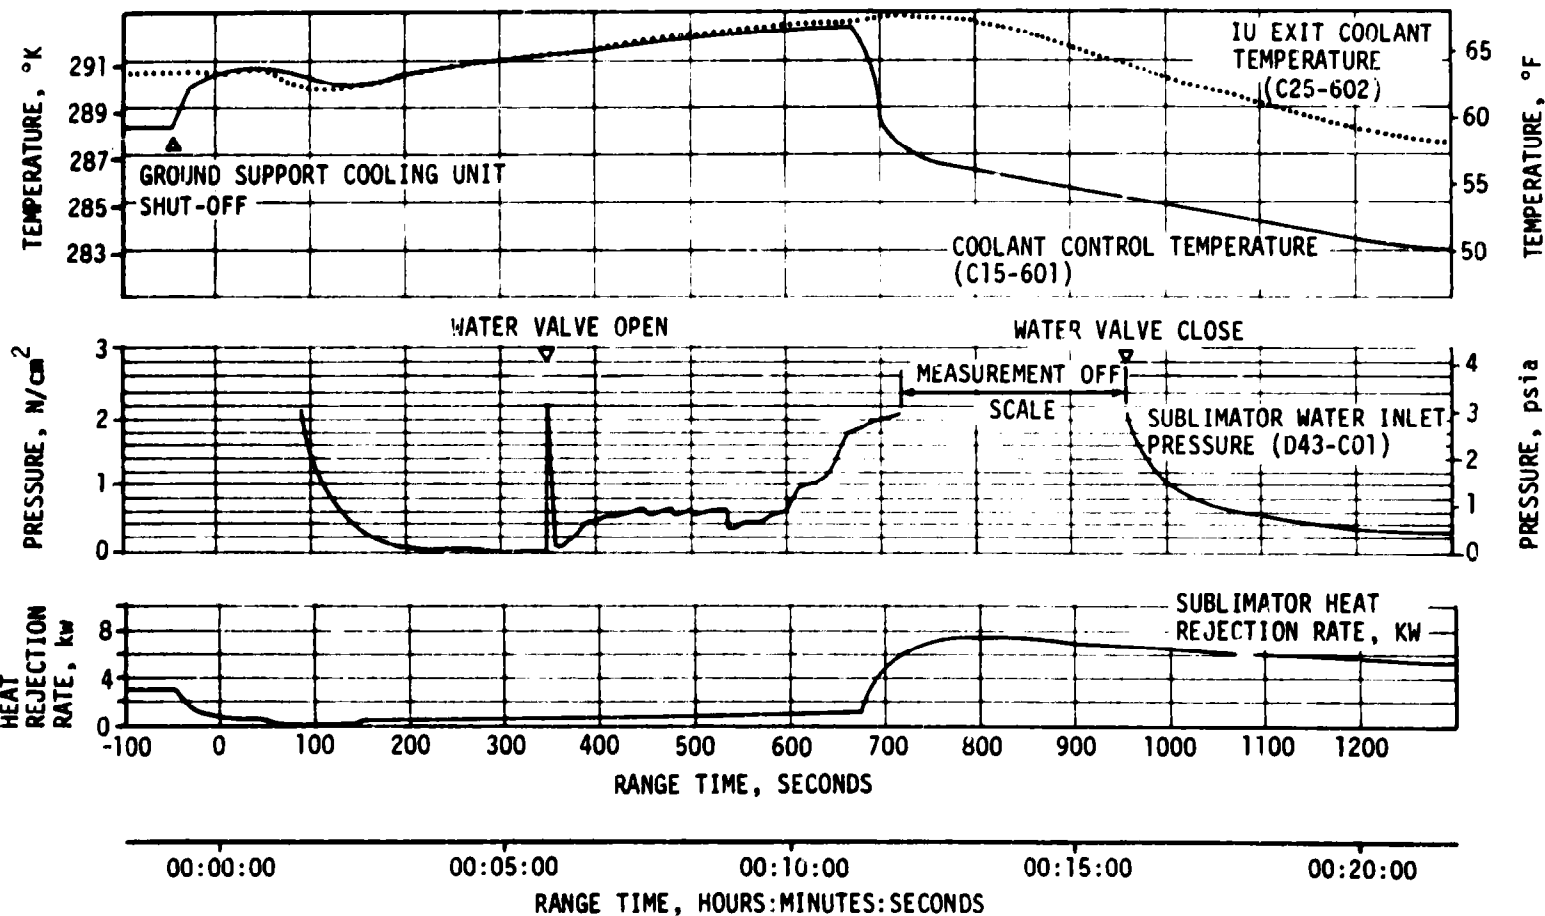
Figure 13-1. IU Sublimator Start-Up Parameters (Initial Cycle)

Effective with IU-513 and IU-114, the Ground Support Cooling Unit (GSCU) is shut down 47 seconds prior to launch by the Terminal Count Sequencer. This was reflected, as shown in Figure 13-1, by an initially rapid increase in coolant supply temperature (C15-601) from the stabilized pre-shutoff value, followed by a more gradual increase through liftoff and the first 60 seconds of flight. This event is similar to that initiated at umbilical separation (lift-off) on all previous flights and does not, in itself, result in a significant change in overall system temperature levels. The

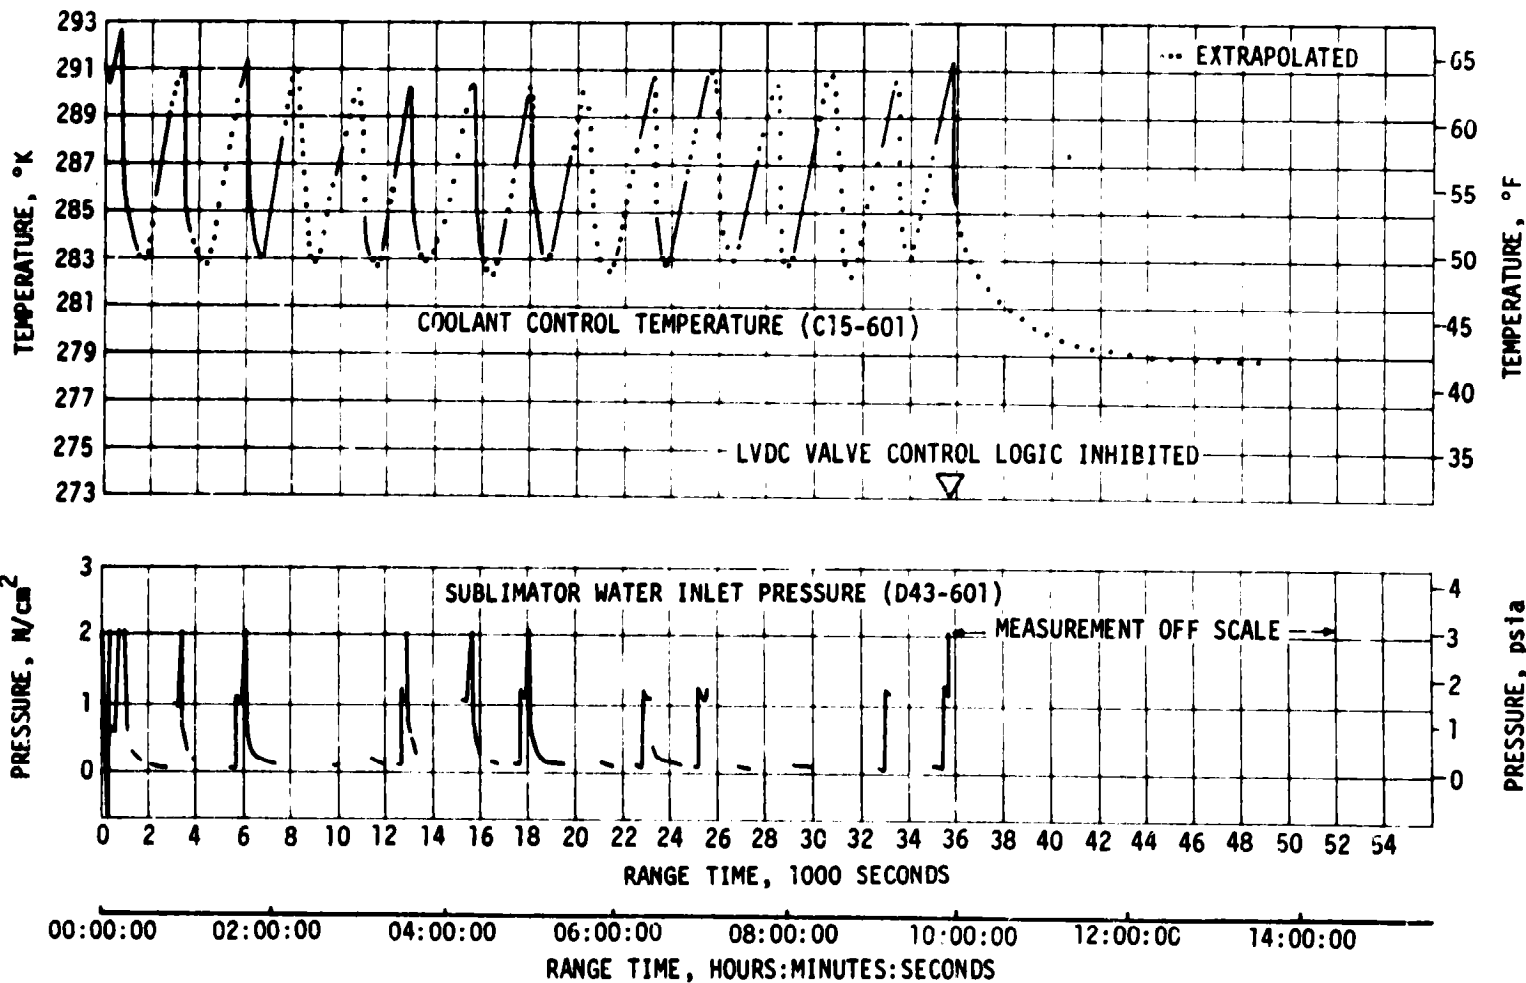
Figure 13-2. IU TCS Coolant Control Parameters

TCS pressurization as indicated by the coolant pump inlet pressure, D24-601, was maintained at the required level of 16 \pm 0.5 psia through 67,000 seconds, at which time the inlet pressure to the First Stage regulator had decayed to less than 200 psia.

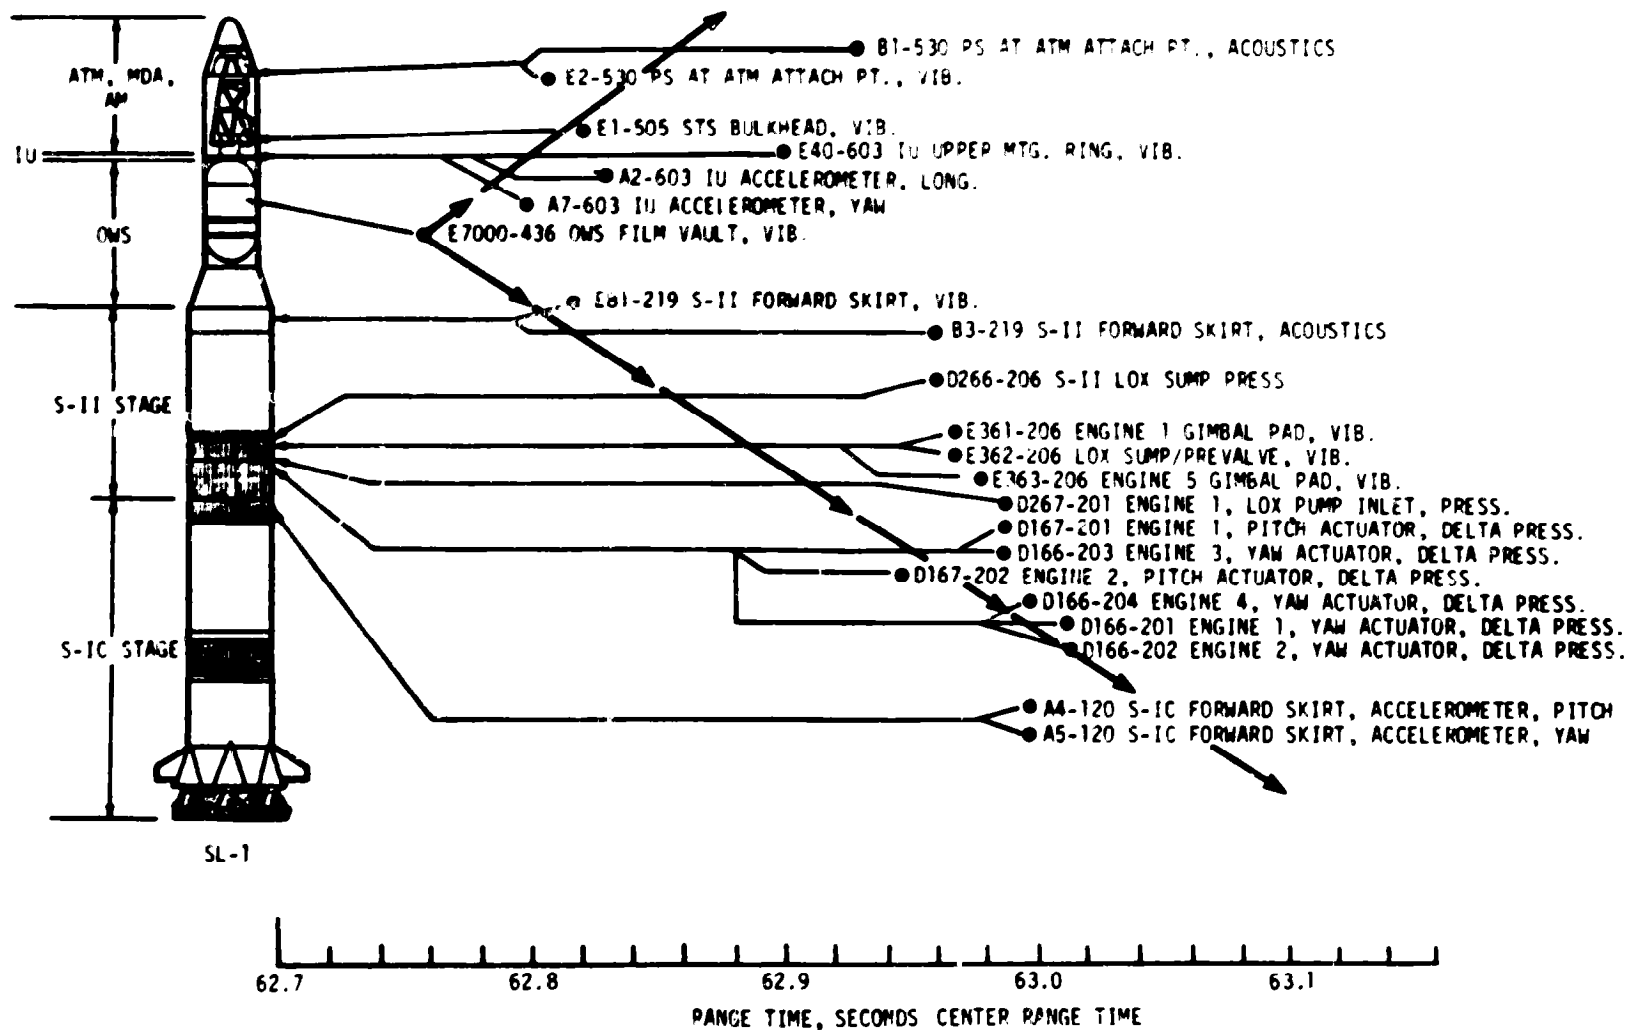
Figure 17-1. Propagation of the 63-Second Transient

At about 62.8 seconds the launch vehicle began to react to the OWS disturbance and the major failure is believed to have started. Table 17-1 presents a MS failure event correlation summary.

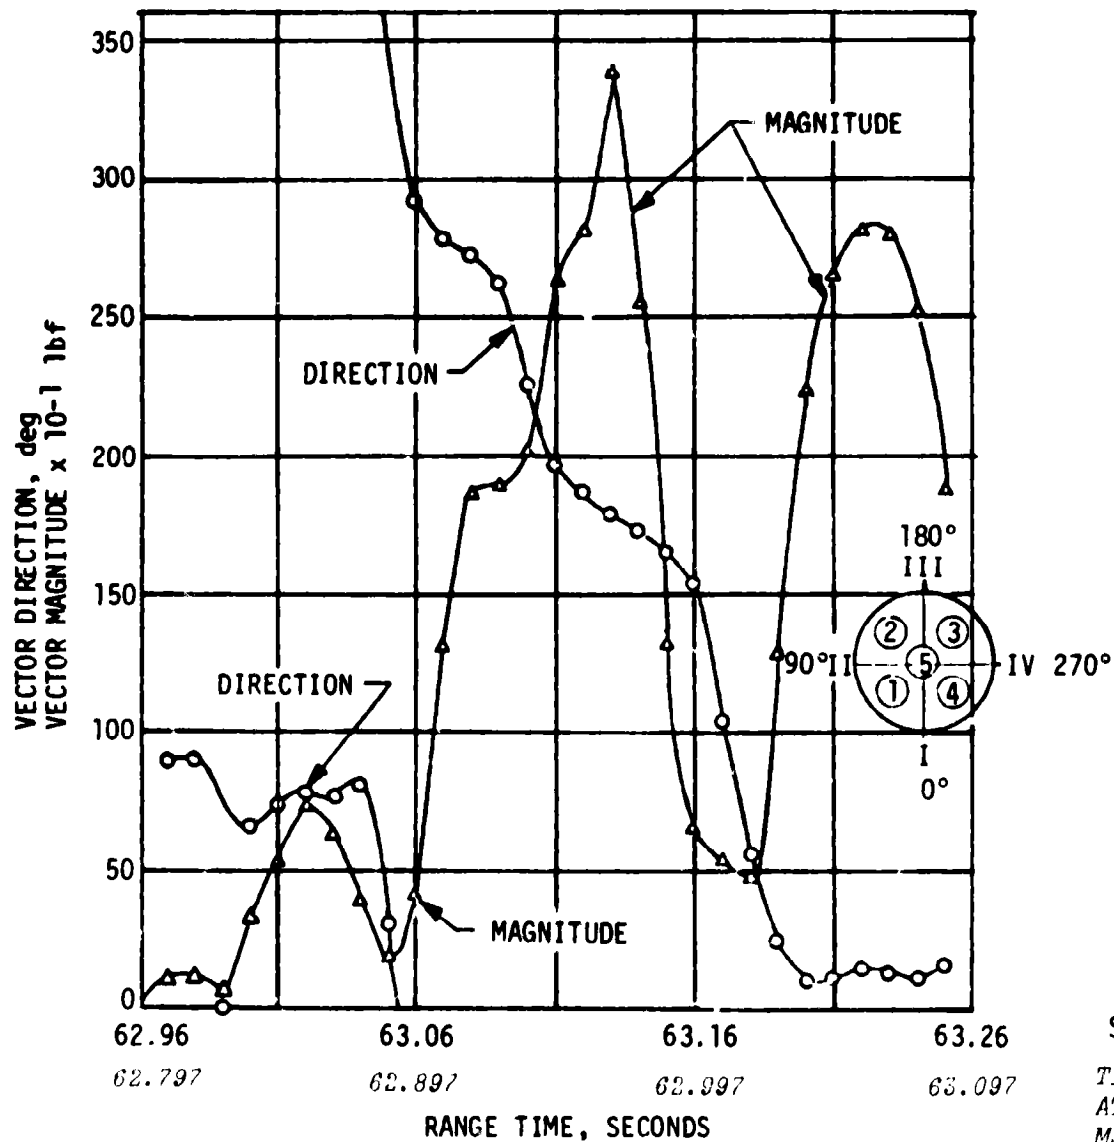
Figure 17-7. S-II Stage Engine No. 1 Actuator Response to the 63-Second Transient

At 62.887 seconds the amplitude of the force begins to increase with the direction changing from vehicle Position I toward Position IV. This is probably the result of the MS continuing to peel around the OWS as depicted in Figure 17-6d. Between 62.907 and 62.937 seconds the MS encounters the SAS Wing No. 2 causing premature deployment. At approximately 62.925 seconds the MS cleared SAS Wing No. 2 and continued to peel toward Position III. At 62.939 seconds temperature measurement C7013, located at Position III, was still normal.

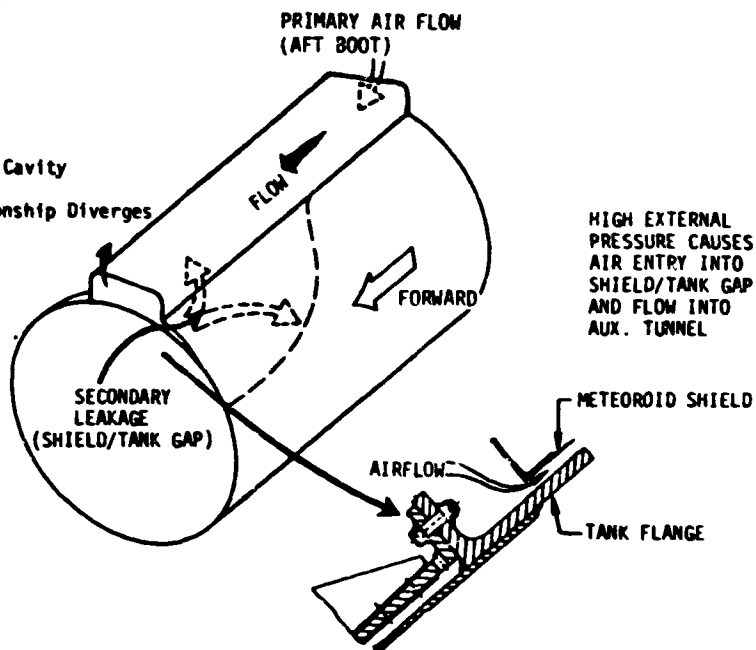
Figure 17-16. Meteoroid Shield Response

- Tunnel Unseats
- Shield/Tank Separates
- Pressure Fills Shield/Tank Cavity
- Deflection-Pressure Relationship Diverges
- Meteoroid Shield Ruptures

tunnel to a condition where the forward tunnel section is subjected to a significant burst pressure. Only 0.2 psi is required to lift the shield. An average pressure of approximately 1.1 psi was applied over the forward 2 to 3 feet of the shield. This force is sufficient to lift the shield edge 2 inches or more as determined by structural test. Figure 17-17 shows the Auxiliary Tunnel Pressure Distribution at 63 seconds (Design Burst Pressure Maximum 0.025 psid). The air flow at the aft end of the auxiliary tunnel permitted a burst pressurization of the tunnel and resulted in lifting of the shield toward the free air stream at approximately 63 seconds. Ram air at approximately 1.05 Mach entered underneath the MS and caused a rapid pressurization and the divergent load-deflection condition led to a structural failure of the meteoroid shield.
